預防蚊子於化數子放生

MOSQUITO PREVENTION

IN SEPTIC TANK

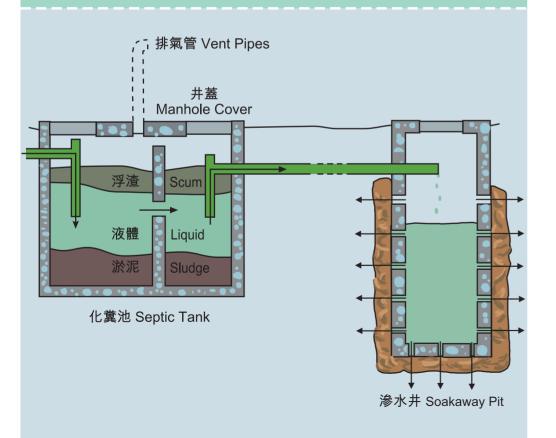
儲存在池內的污水會被細菌分解為頂層的浮渣,中層的液體及底層的淤泥。中層的液體會由化糞池排放。

Septic tank is commonly used for wastewater disposal for village houses in areas where no communal sewer is available. Wastewater is retained in the tank for breaking down by bacteria and separation into three layers, namely the scum on the top, the sludge at the bottom, and the main body of liquid which is then discharged from the septic tank.
