# 預防蚊子於 化糞池滋生

## MOSQUITO PREVENTION IN SEPTIC TANK

食物環境衛生署  
Food and Environmental  
Hygiene Department

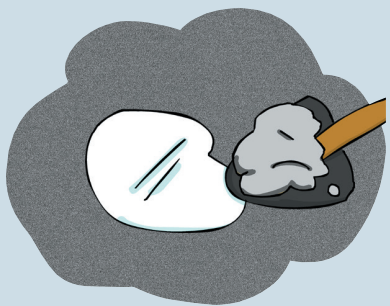
# 5

化糞池附近凹陷的地面已填平，以防積水。

All defective ground surfaces near the septic tank have been levelled to avoid accumulation of stagnant water.

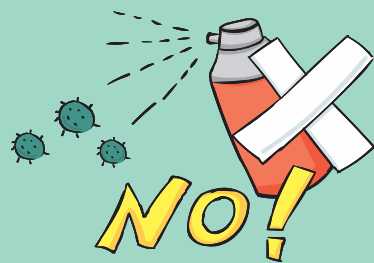
切勿將油或化學品 (如殺蟲劑) 放入化糞池。因為油會將滲水井周圍泥土內的小孔堵塞，令化糞池不能排放液體；而化學品會殺死化糞池及泥土內自然生長的細菌，這些細菌有助分解液體中的污染物。

Do not apply oil or chemicals including pesticides into the septic tank. Oil will clog up the pores in the soil around the soakaway pit and block the discharge of effluent. Chemicals may kill the bacteria naturally present in the septic tank and the soil. These bacteria help decompose the polluting matter in the liquid.

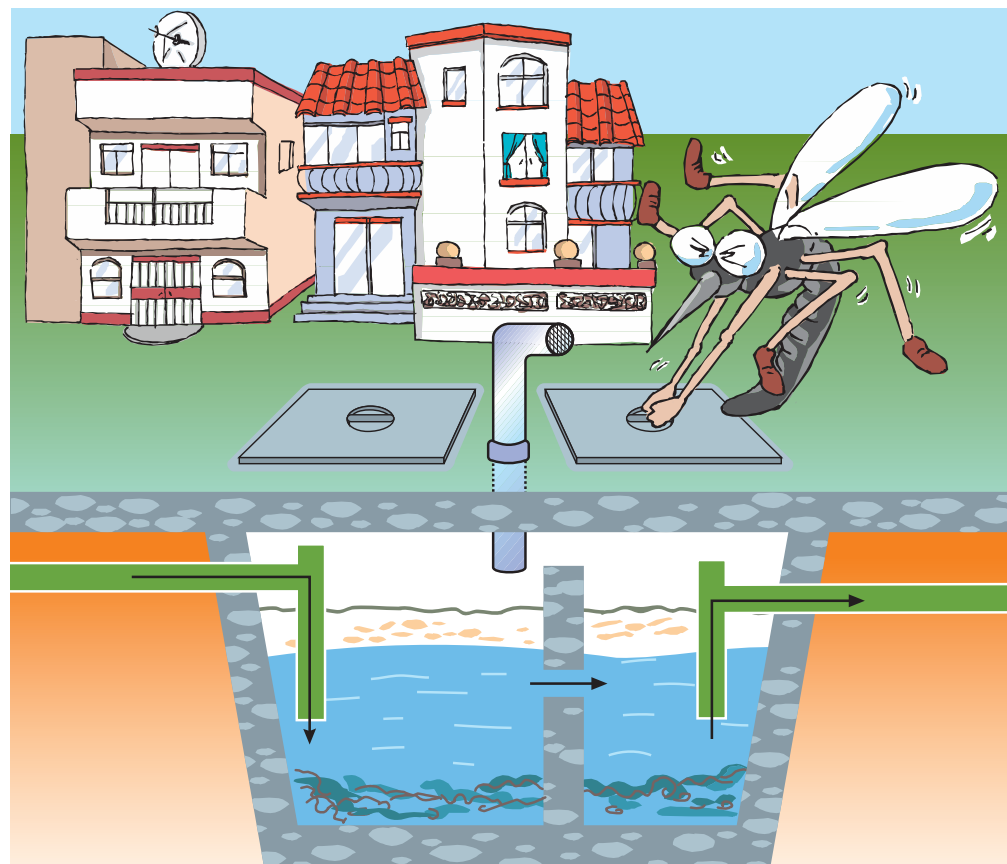
在未鋪設公共排污渠地區的村屋，化糞池是一般用作處理污水的設施。

儲存在池內的污水會被細菌分解為頂層的浮渣，中層的液體及底層的淤泥。中層的液體會由化糞池排放。

Septic tank is commonly used for wastewater disposal for village houses in areas where no communal sewer is available. Wastewater is retained in the tank for breaking down by bacteria and separation into three layers, namely the scum on the top, the sludge at the bottom, and the main body of liquid which is then discharged from the septic tank.

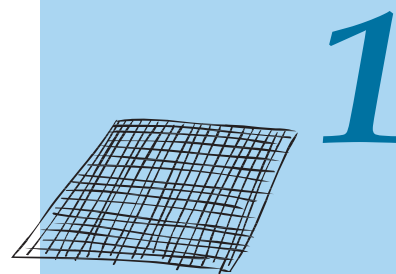
# 1

化糞池的排氣管及其他氣孔已裝上蚊網，以防止蚊子飛入（每平方厘米有30至40個網孔的蚊網可阻隔大部分蚊子）；

Mosquito screens have been installed at the vent pipes and other openings of the tank as appropriate to prevent mosquito from flying into the tank (screens with 30-40 meshes per square cm will keep out most mosquitoes);
